## Safety Bulletin

33449A01

### Ibsophone Communication Line

Important information regarding reliving loop on Ibsophone Communication Lines

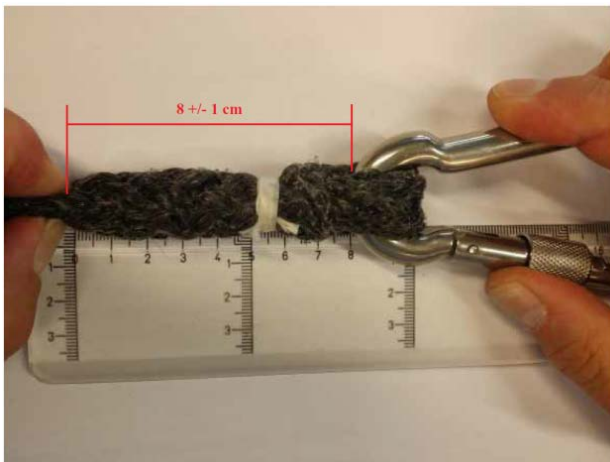
Interspiro has been informed that some Communication Lines have been delivered with a too short reliving loop. This can make the reliving loop slip on the communication line when subjected to force. In order to make sure that the reliving loop on the communication line is correctly made, the following measurement can be done.

- 1) Stretch the loop firmly.
- 2) Measure the total length of the loop as shown on the picture below. The measure from the beginning of the loop should be 8 +/- 1 cm (7 - 9 cm).

If the loop is not correct, the communication Line shall be sent to Interspiro for corrective actions.
